TOWN OF DURHAM

Francis E. Korn School

FINAL REPORT

ADAPTIVE REUSE FEASIBILITY REPORT:

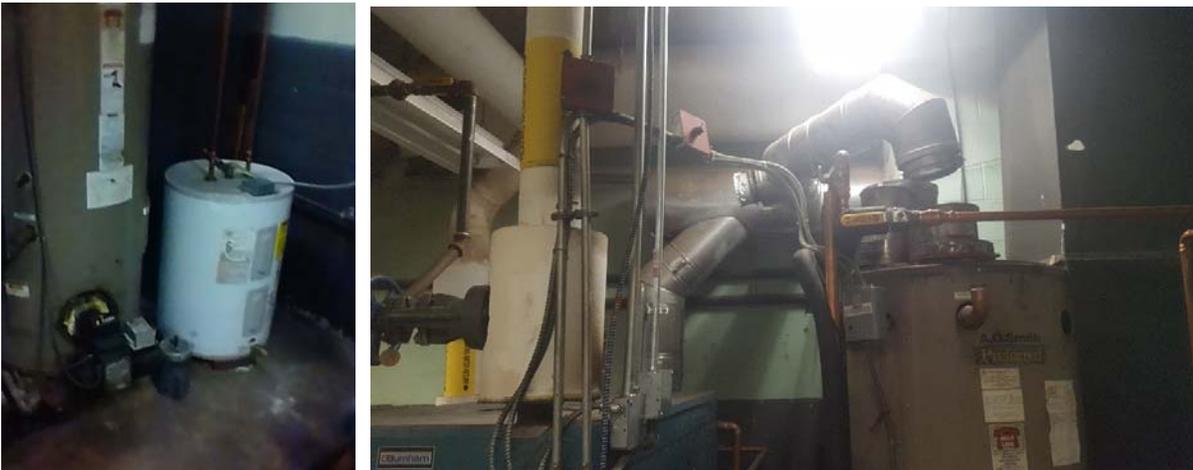
The existing domestic water heater was an oil-fired storage heater (input rating of 199,000 BTUH, storage volume of 86 gallons). However, this heater failed just before the building ceased school operations, and was disconnected from water, fuel and flue gas venting systems. A small electric water heater (4500W/3380 upper/lower elements-simultaneous use, storage volume of 20 to 30 gallons) was connected adjacent to the defunct heater and served a handful of RSD 13 staff for a year or two.

- **Work required:**
 Replace oil-fired water heater (new Bock 71E), reconnect: \$5000
 Replace general use system circulating pump (new Taco, 1/25 hp): \$500
 Inspect/clean or replace thermostatic mixing valve: \$500
- **Charges: Post-installation State-required boiler/storage vessel inspection: Estimated \$250**

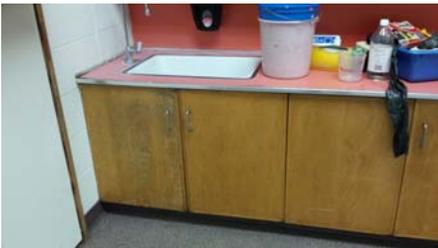
Plumbing fixtures are in good repair. The only fixtures not in very good to excellent condition are sinks in classrooms which did not receive ADA modifications in 2002. These sinks are the original counter-mounted enameled cast iron sinks with stainless steel rims. Cabinets in these rooms are also original and worn, but useable.

- **Work required:**
None, unless additional classroom sink ADA upgrades are desired.

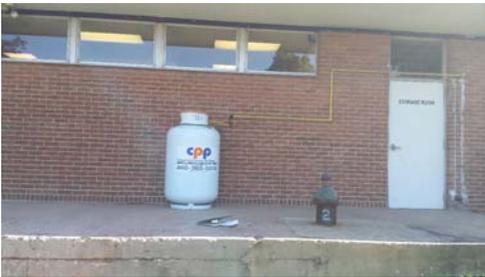
An above-ground 120-gallon propane tank is located on the concrete loading dock pad outside the kitchen on the south side of the building.

The condition of this tank is unknown, but there is no visual evidence of significant corrosion. The propane tank presently serves kitchen gas-fired equipment, a rooftop makeup air unit (which according to RSD personnel was rarely operated) and a 15 KW emergency generator.

- **Work required:**
 - No additions to LP-gas fired equipment: None**
 - Change oil-fired water heater to LP-gas fired heater: Additional distribution piping, and possible additional tank storage capacity.**

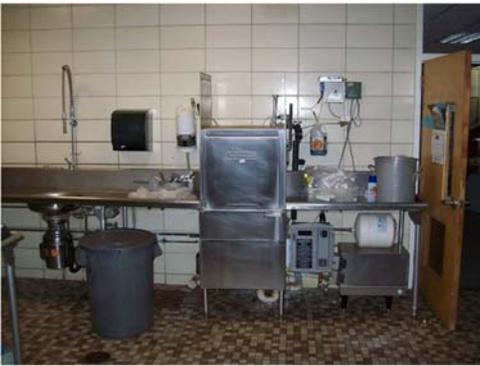
A recessed grease trap was observed under the soiled dish table adjacent to the dishwasher:

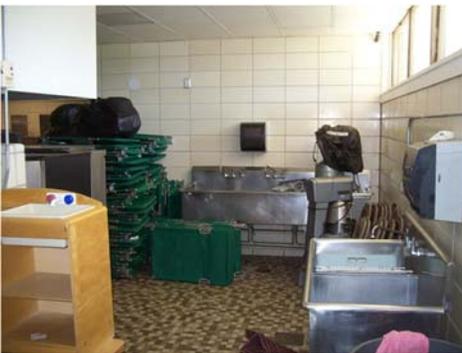
A grease trap was not found for the 3-bay pot sink (farthest sink in photo below); if this sink is used for pot washing, a grease trap would be required per DEEP regulations:

There are no dedicated hand sinks in the kitchen, as required by the State Health Code. The kitchen does not have accessible provisions, which would include ADA access clearances, ADA-compliant hand sink and ADA-compliant food prep station (table/sink).

- Work required:
 - Add grease trap to 3-bay sink
 - Add dedicated hand sink
 - Add ADA hand sink
 - Add ADA prep table/sink

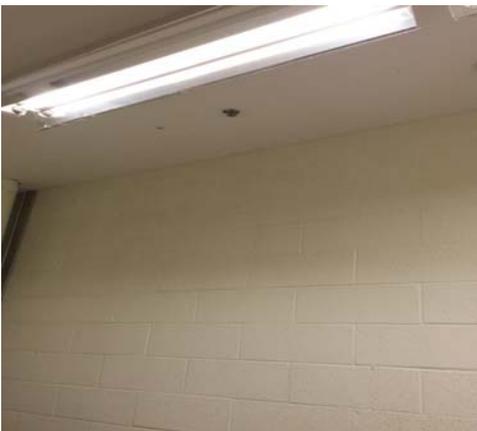
The building is not fully sprinklered. Areas such as storage rooms, janitor's closets, boiler and other mechanical rooms, electrical rooms and kiln room have been sprinklered to achieve code compliance for fire protection/ separation. The sprinkler systems appear to be in good condition. Kiln Room pictured below:

- **Work required:**
Add sprinkler systems per code requirements for implemented building uses.
A/E design; Contractor's site verifications, shop drawings and hydraulic calculations

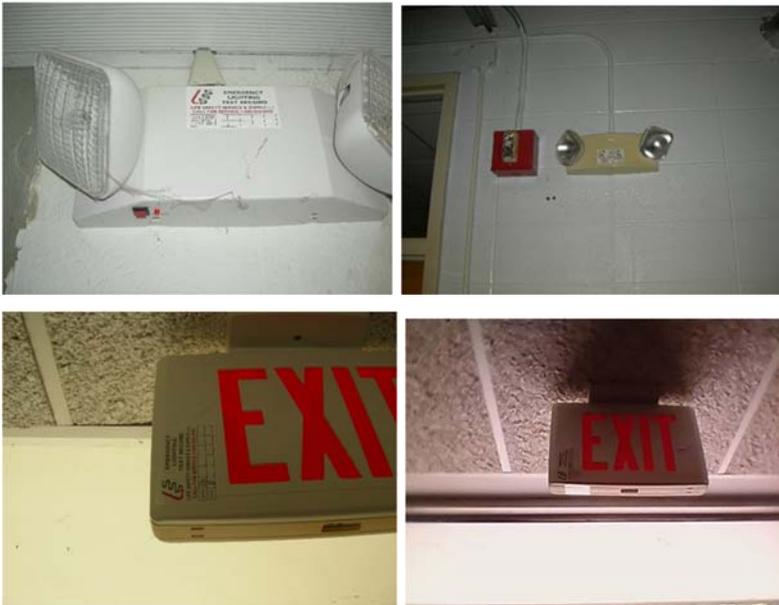
Emergency Lighting & Exits

Visually they look OK although a few were randomly tested and did not function.

Exit and emergency lighting throughout the building needs to be inspected and run through a 90-minute test to ensure proper function.

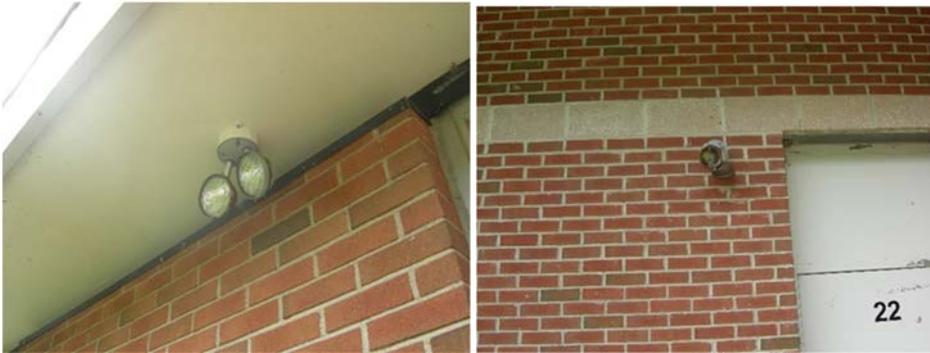
Emergency Egress

Low voltage aluminum / chrome par heads mounted. Many were in rough shape, a few were broken.

All exterior emergency lighting should be evaluated against current & upcoming code requirements; power density, daylight controls, occupancy sensor functionality. Most of the lighting is outdated, LED exterior lighting replacements should be considered.

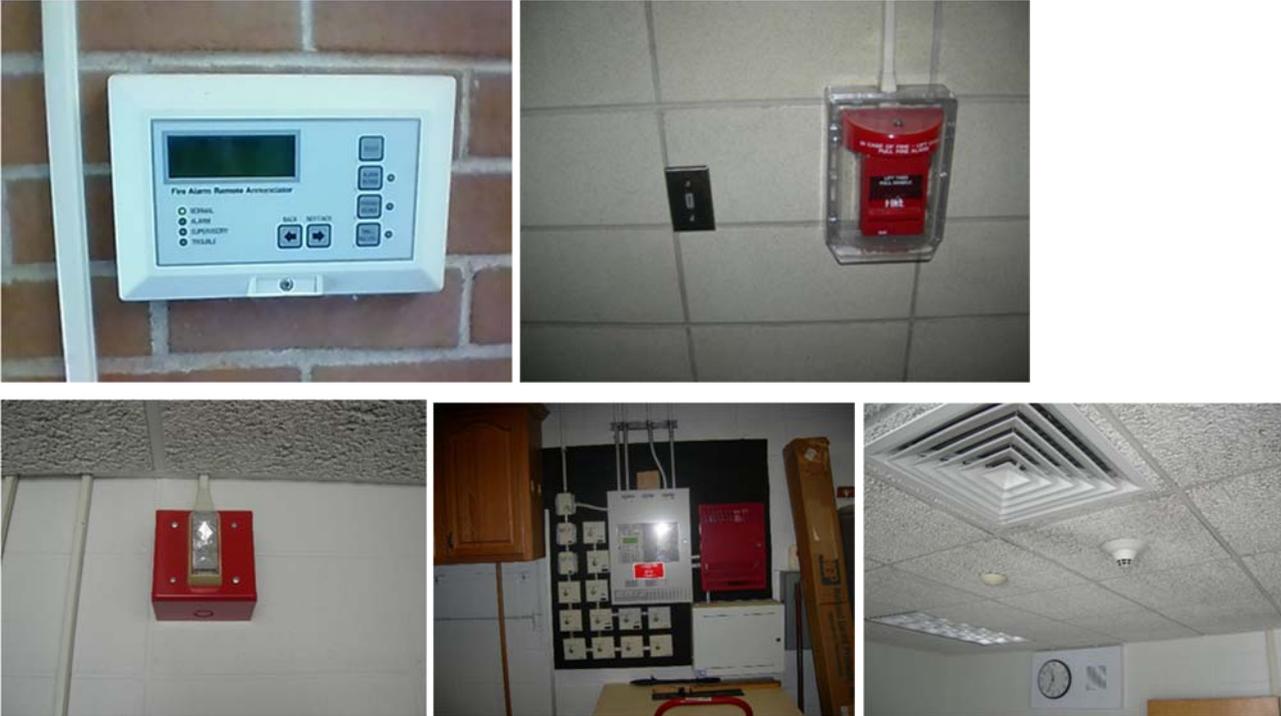
Fire Alarm System

Edwards EST2 - 2001 vintage. Function unknown / untested. Appeared to be functional - no alarm indications were seen.

- **Recommendations:**
FA system and associated devices should be tested and certified on proper function.

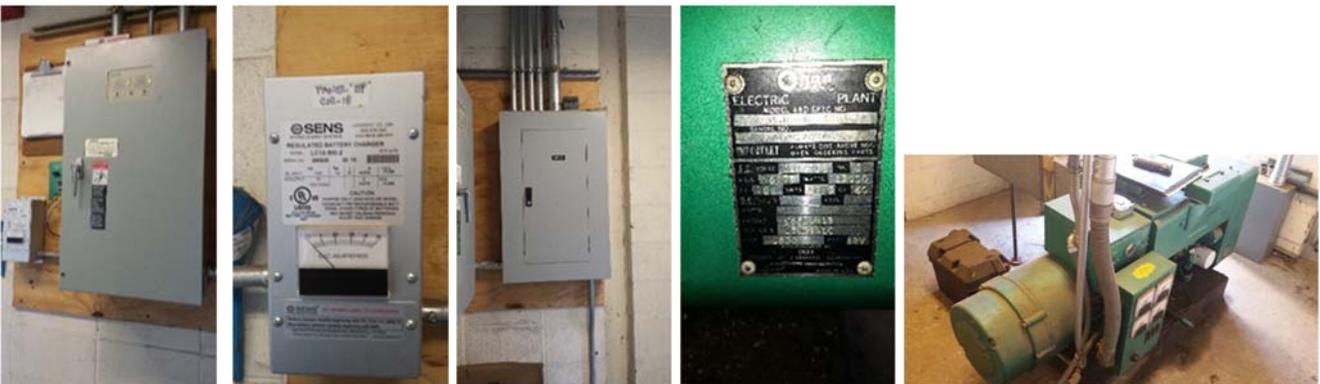
Emergency Generator

Function and visual - appears to be functional.

- **Recommendations:**
The generator system should be tested and certified on proper function.
