TOWN OF DURHAM

Francis E. Korn School

FINAL REPORT

ADAPTIVE REUSE FEASIBILITY REPORT:

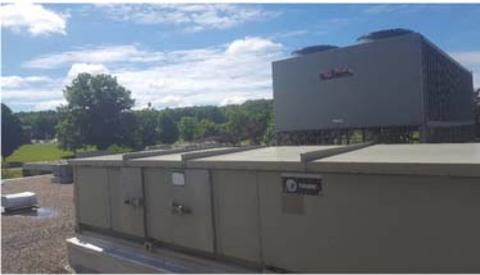
Typical Air Handling Unit with Chiller in Background

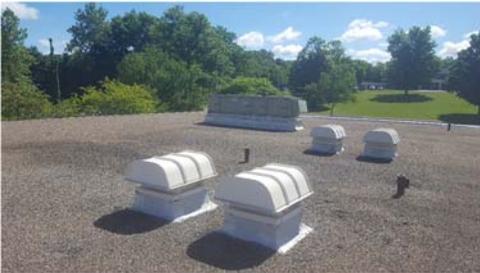
Classroom Air Handling Unit with Relief Ventilators

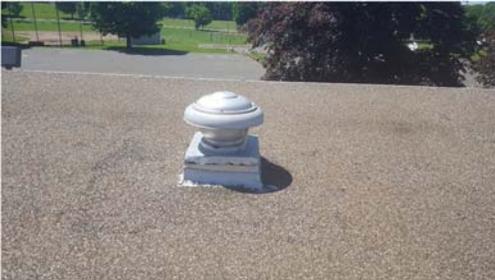
Kitchen Hood Grease Exhaust Fan (Likely not code compliant)

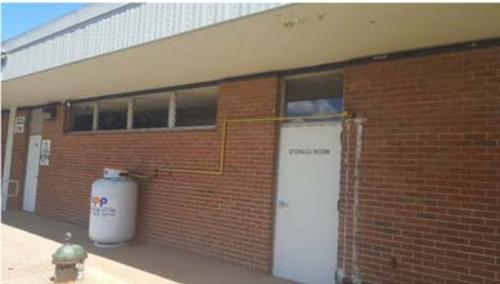
Propane Tank Installation for Kitchen Makeup Air Unit

The condition of this tank is unknown, but there is no visual evidence of significant corrosion. The propane tank presently serves kitchen gas-fired equipment, a rooftop makeup air unit (which according to RSD personnel was rarely operated) and a 15 KW emergency generator.

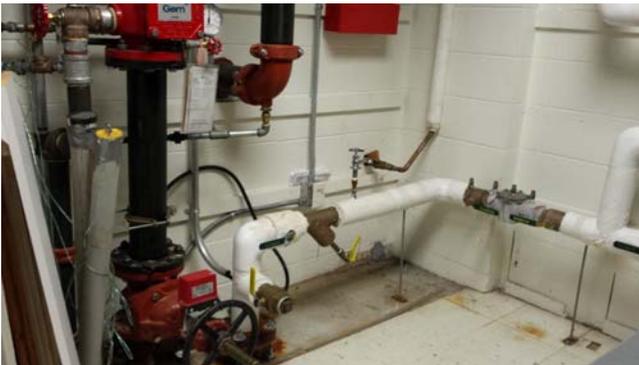
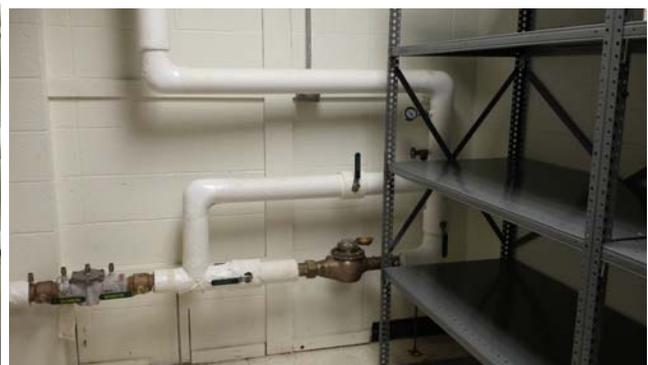
The building's 4" domestic water service is routed from a Regional School District #13 well water supply system fed from multiple wells, one of which is located just south of Korn School. The well water supply system serves the subject building, Frank W. Strong Middle School, and Cuginchaug Regional High School. The 4" domestic water service enters the building in Storage 117, near Lobby 100. The service entrance transitions immediately to 2", and includes a main service shutoff valve, strainer, water sampling faucet, double check valve backflow preventer assembly, and 2" meter with full sized bypass. The pressure gauge downstream of the meter and bypass branches read 68 psig at the time of the Engineer's visit. A 2" cold water main leaves Storage 117 to supply the building's domestic water demands.

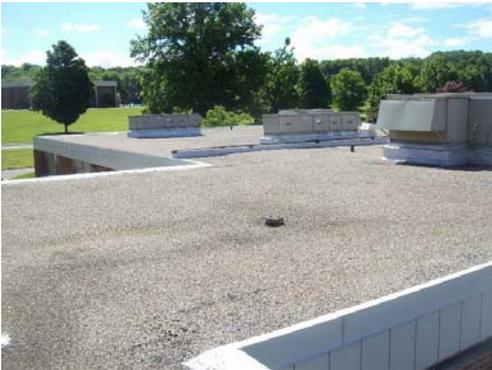
Separate primary and overflow roof drainage systems have been installed:

Some east wing classrooms and the Boiler Room area appear to have experienced storm water leakage due either to roof or storm pipe leaks, or clogged roof drains. In coordination with inspection of the roof itself, the roof drains and pipes in areas with historical drainage issues should be scoped with a camera to determine the cause of the issues.

- **Work required:**
 - Clean out (unclog) roof drains.**
 - Inspect drains/pipes for leaks and repair.**
 - TV Scoping if necessary:**

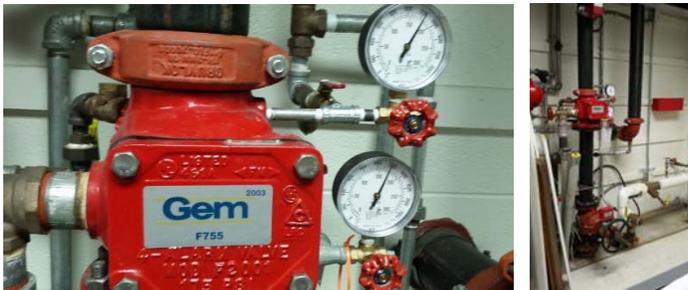
The building's 8" fire service is routed from a Regional School District #13 well water supply system fed from multiple wells, one of which is located just south of Korn School. The well water supply system serves this building, Frank W. Strong Middle School, and Coginchaug Regional High School. The 8" fire service enters the building in Storage 117, near the main entrance and Lobby 100. The service entrance transitions immediately to 4", and includes a main service shutoff valve, alarm check valve, 2" main test/drain, 4" fire department connection, and 4" wet pipe sprinkler feed main to building sprinkler systems. The pressure gauge at the discharge of the alarm check valve read 140 psig at the time of the Engineer's visit:

A separate project is underway to connect the fire services of these buildings to a new municipal utility water supply main being extended south from Middletown. The static pressure in the new water main in the vicinity of this building is projected by the designers to be 65 psig. Once the service changeover is complete, the existing "campus" well water system, complete with wells, vaults, pumps and storage tanks, is expected to be abandoned and possibly demolished. The water utility is expected to connect to the existing Korn fire service outside the building. A backflow preventer installation (likely double check valve type) will be required on the utility-supplied fire service, located between the main shutoff valve and the alarm check valve. It will be necessary to disconnect and relocate the alarm check valve upward on the riser to achieve the lay length necessary for backflow preventer installation.

- **Work required:**
Modify service entrance; install backflow preventer of type required by water utility:
\$8500
- **Charges:**
Possible fire service connection fee (Durham Central Water/CT Water).
Durham Central Water/CT Water Co. annual backflow preventer inspection fee.

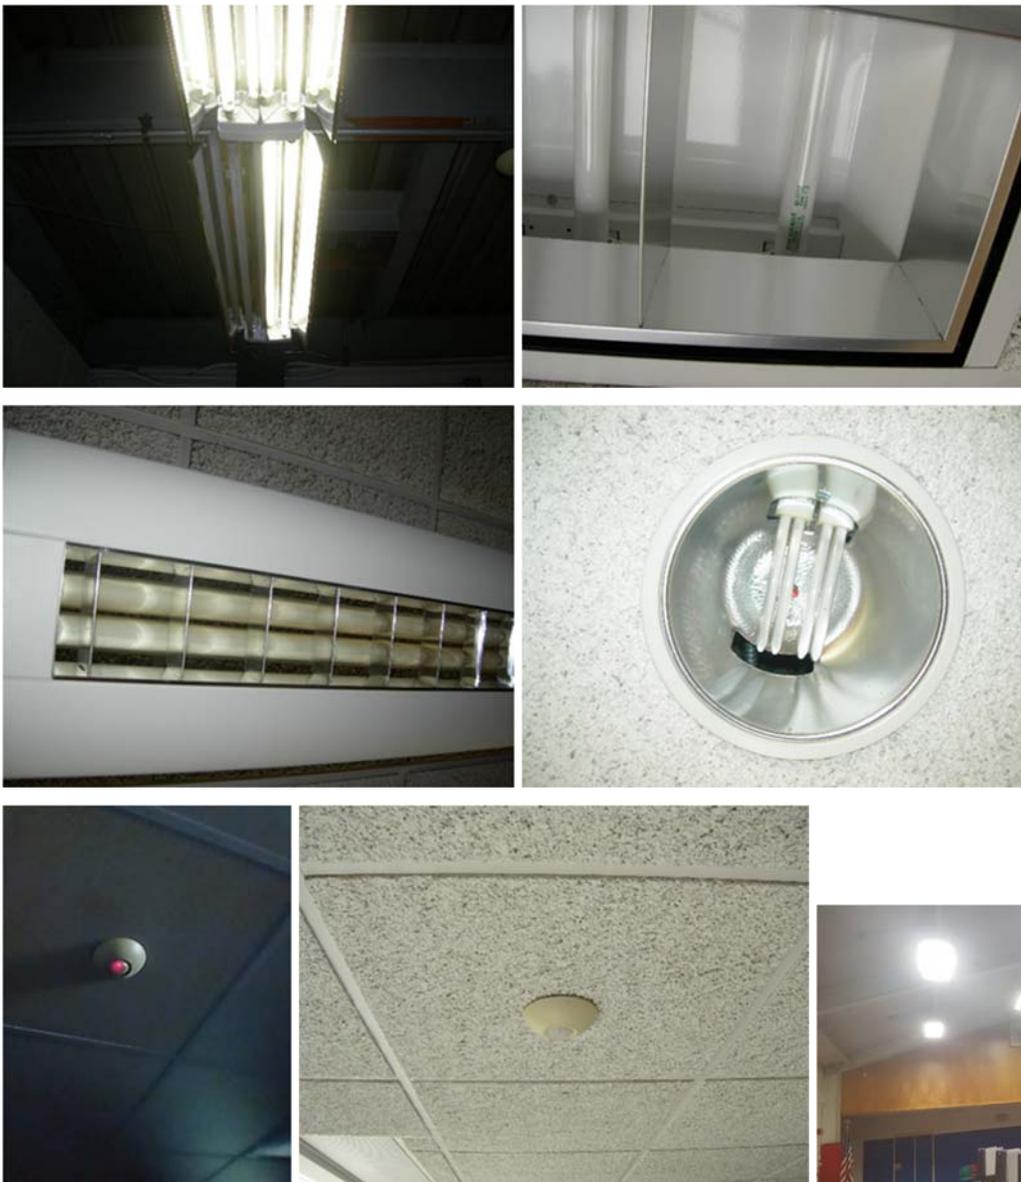
2001 vintage; visual many are showing ware and are not energy efficient in today's standards. All current codes appear to be met with occupancy sensors where required; most appeared to be functional.

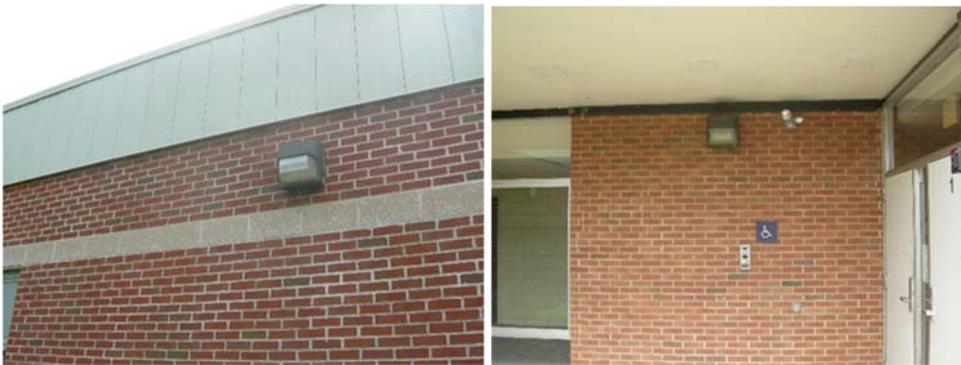
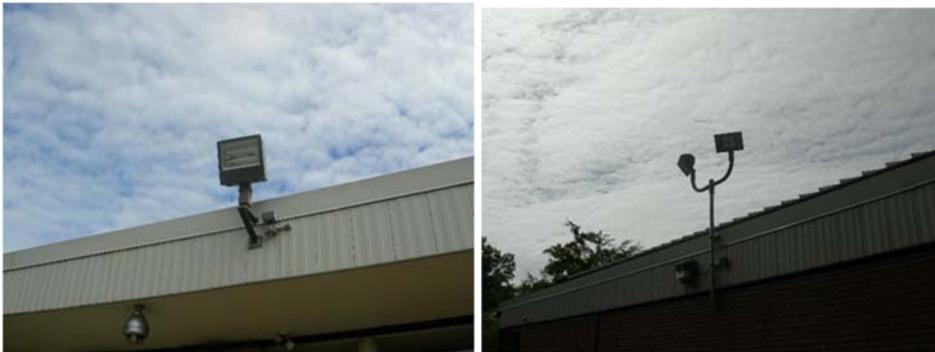
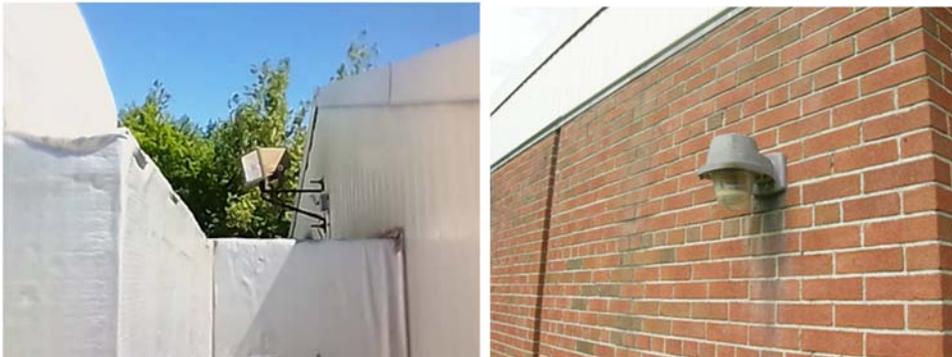
- **Recommendations:**

Exit and emergency lighting throughout the building needs to be inspected and run through a 90-minute test to ensure proper function.

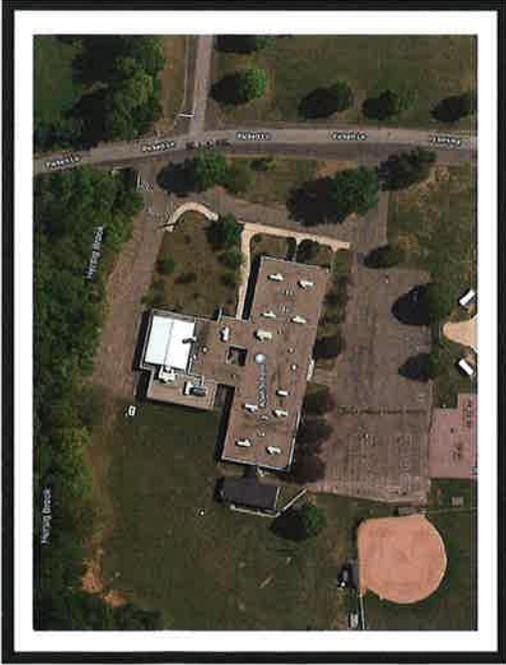
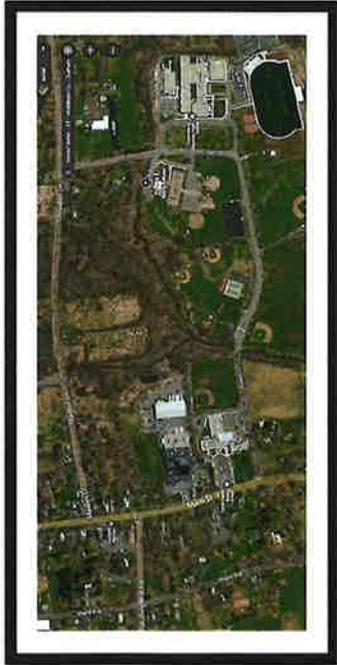
EXISTING SITE CONDITIONS

- Site accessibility
- Paving conditions
- Building entrances
- Removal of portable classrooms

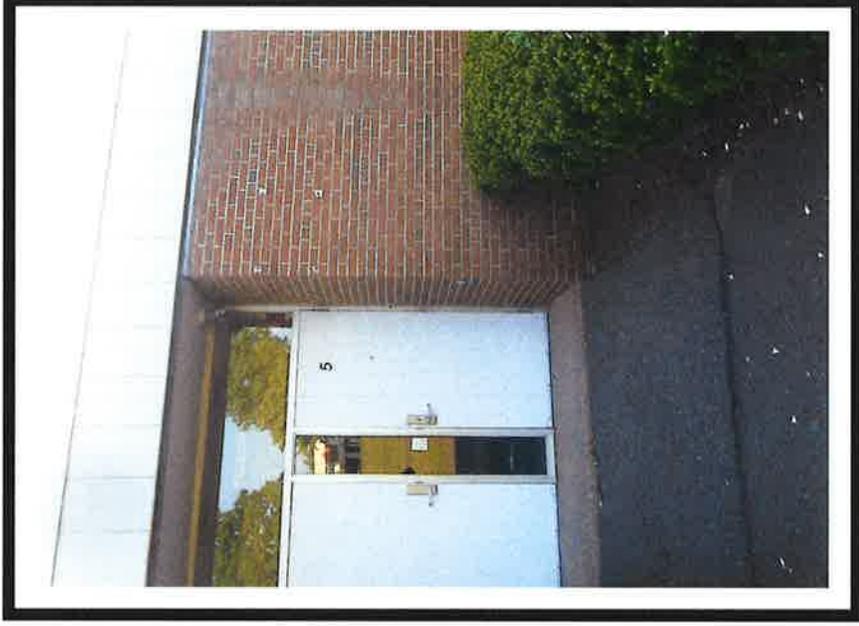
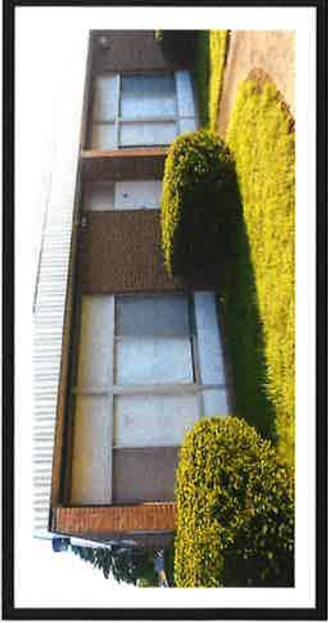
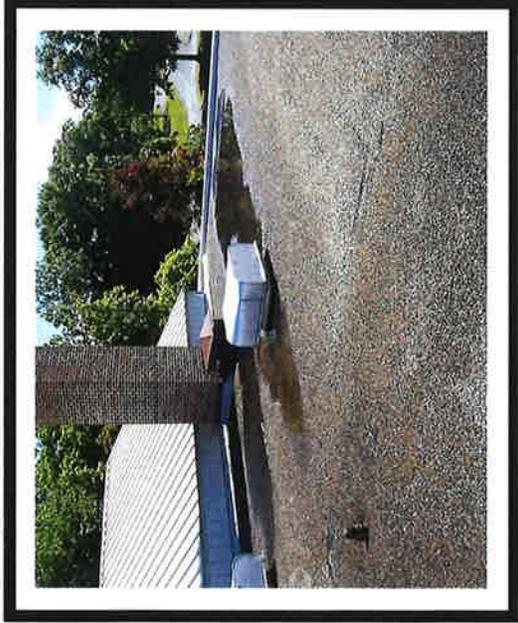
EXISTING EXTERIOR CONDITIONS

- Window & Door conditions
- Roof condition
- Masonry repairs

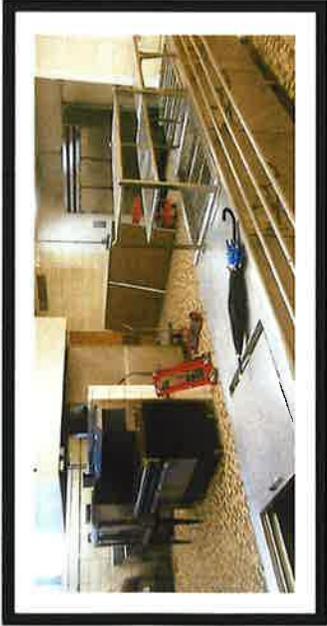
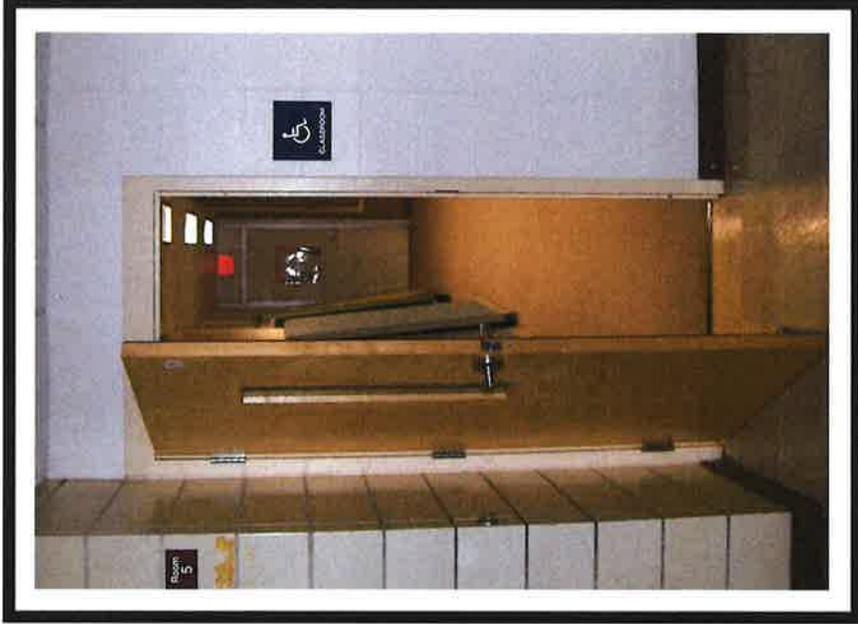
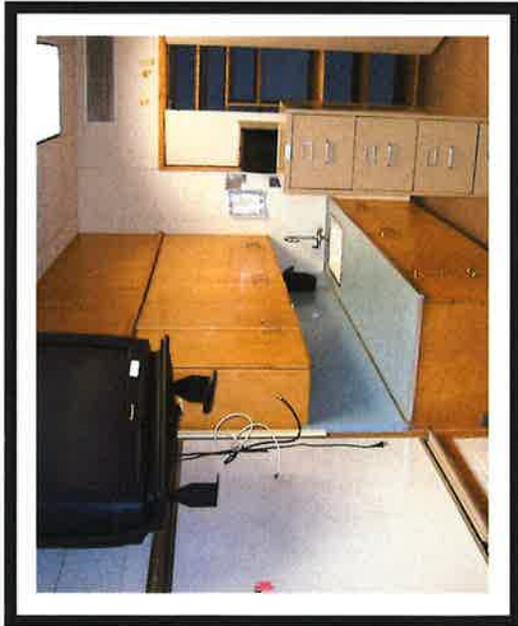
EXISTING INTERIOR CONDITIONS

- Kitchen upgrades
- Casework accessibility
- Door & Hardware upgrades
- Abatement

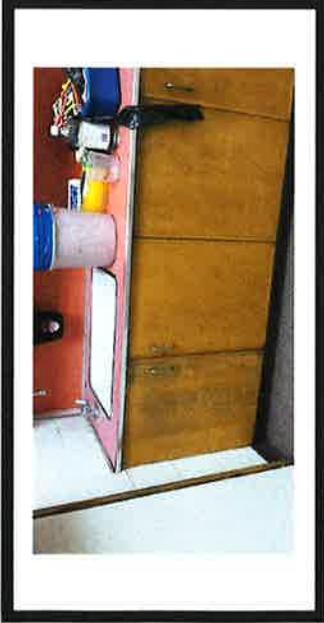
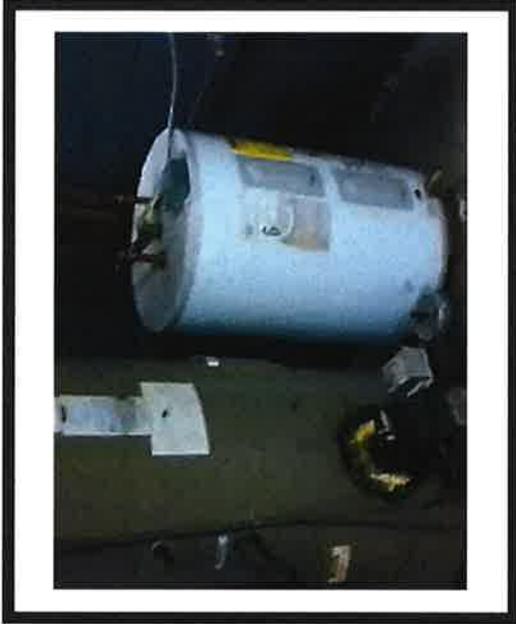
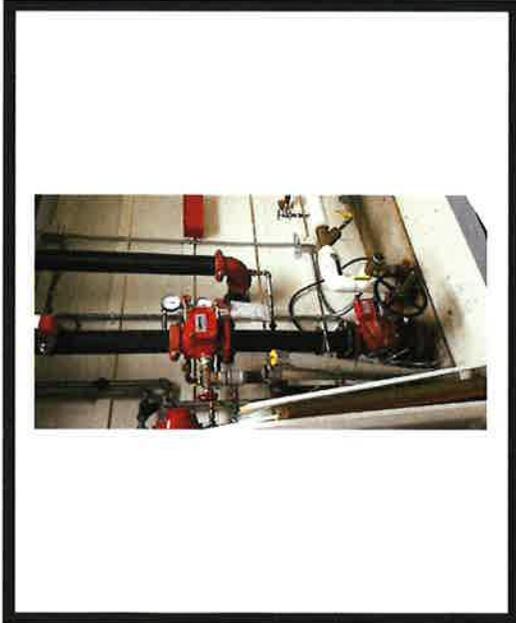
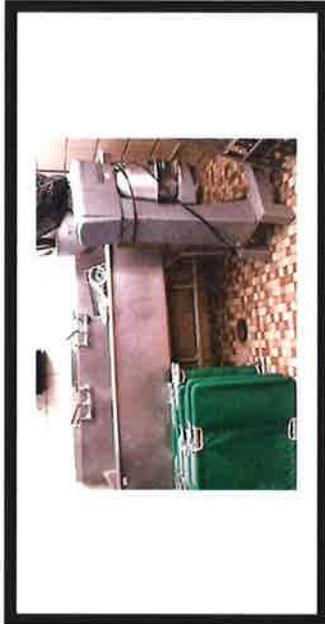
EXISTING PLUMBING/ FIRE PROTECTION CONDITIONS

- Modify sink for ADA compliance
- Add fire service backflow preventer
- Replace fuel-fired domestic water heater
- Provide grease interceptor on 3-Bay pot sink

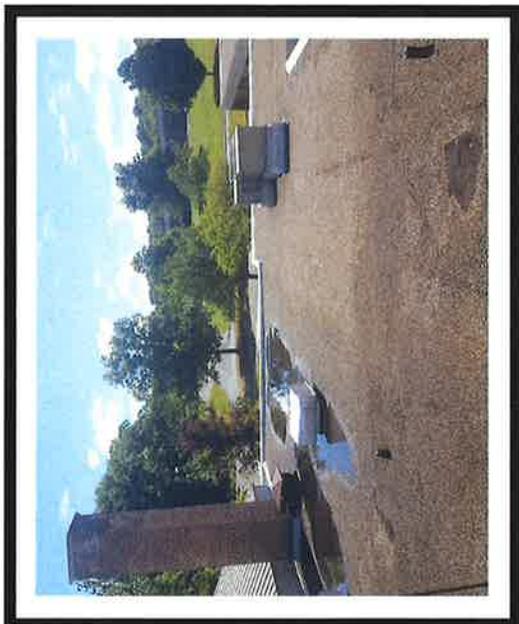
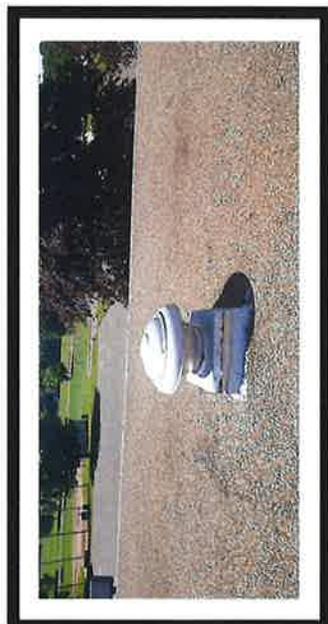
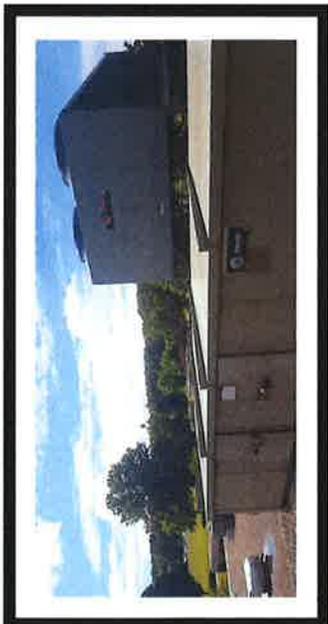
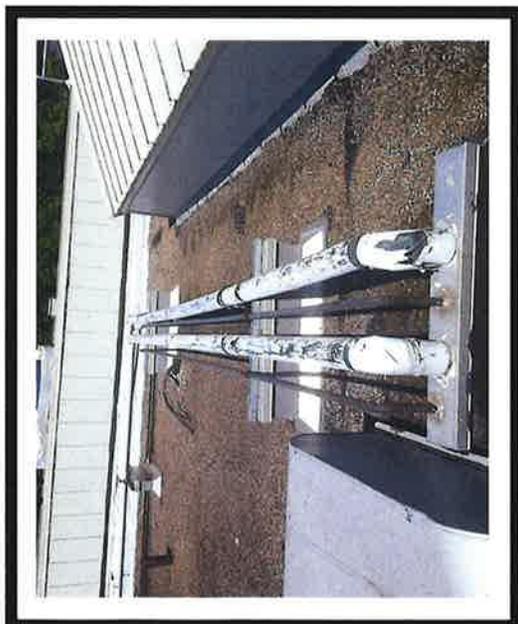
EXISTING MECHANICAL CONDITIONS

- Wear and tear of rooftop equipment & chiller
- Deteriorated insulation of rooftop piping
- Incorrect kitchen fan

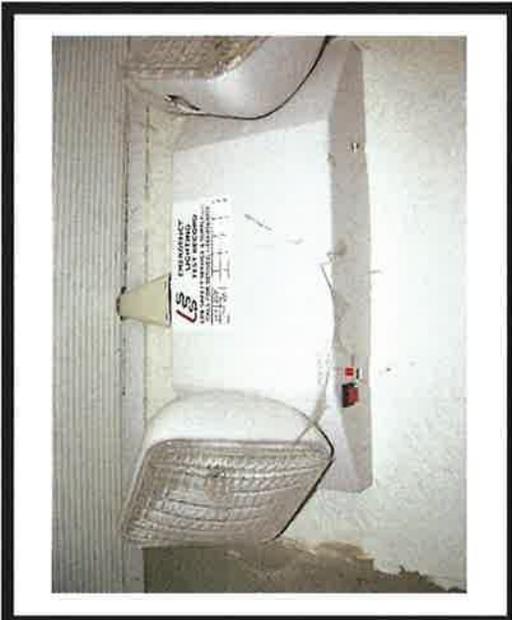
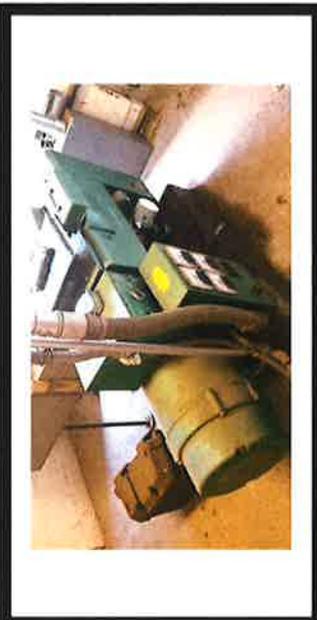
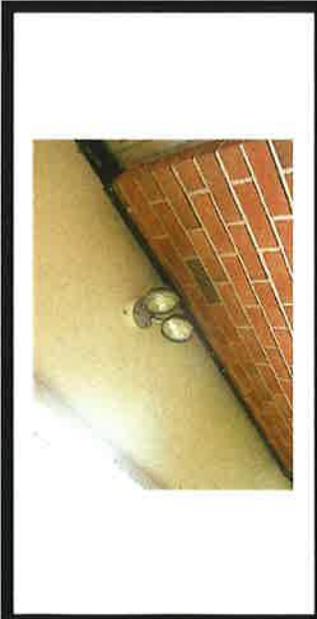
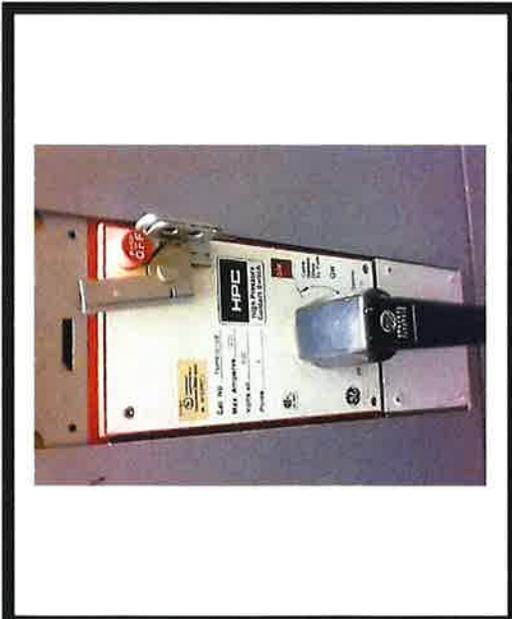
EXISTING ELECTRICAL CONDITIONS

- Emergency egress lighting
- Main service panel
- Emergency lights
- Emergency generator
